Issues faced by the Submarine cable industry due to illegal anchoring

TGN-IA Cable System

- System in service March 2009
- Initial Capacity of 650Gbps and Design Capacity of 3.84Tbps
- Connecting Singapore to Japan and US
- 4 repairs between Mar and Nov-2009, in Singapore Straits one before service and three while in service

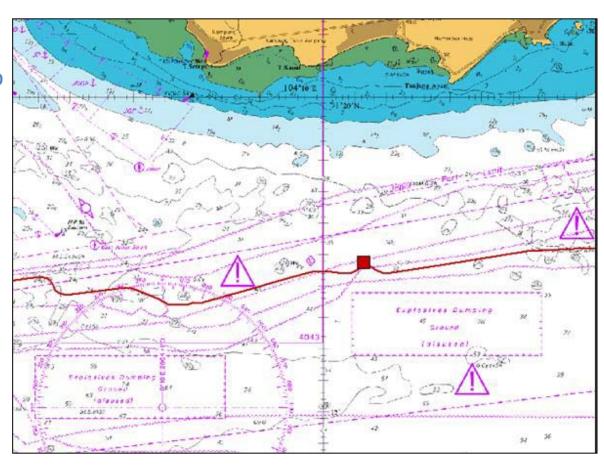
Fault during June-2009

- Fault location, 1° 17.27N and 104° 10.62E, close to prior to service fault
- Within Westbound Lane Of TSS
- Ship departs for Repair Grounds, June 15th, 13:17
- Time to get to Repair Ground, 7 days. Total Time of Repair 6 days & 10 hours
- Approximately US\$500k to repair

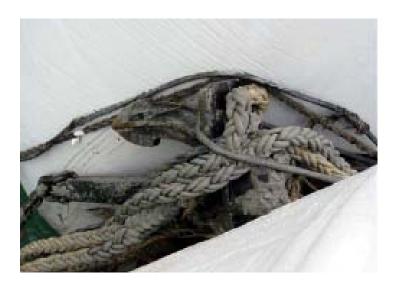
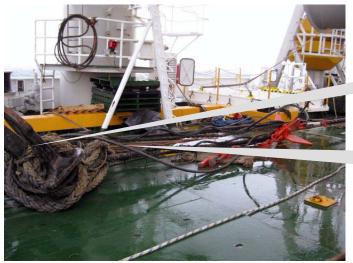
Fault during June-2009

Large Anchor (1.6 Tons) hooked the cable and dragged cable until mooring line of anchor parted or was cut. The Anchor and cable came up to the Aft Deck of the repair ship with submarine cable entangled.

Large Anchor with cable wrapped around

Submarine Cable entangled with Anchor

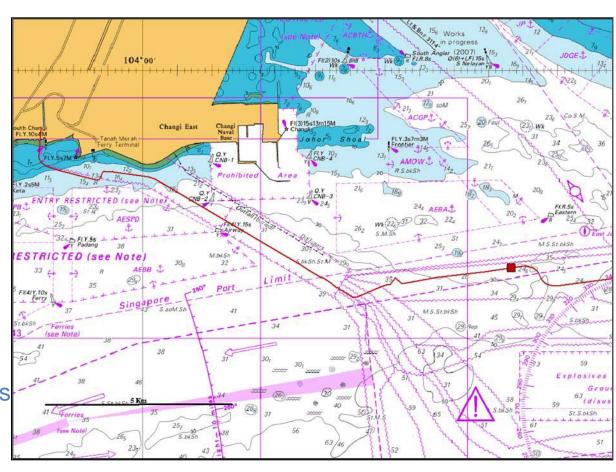
Fault during September-2009

- Shunt Fault
- Fault location, 1° 17.12N
 and 104° 05.32E
- Within Westbound Lane Of TSS
- Ship departs for Repair Grounds, October 15th, 22:30
- Time to get to Repair Ground, 2 hours. Total Time of Repair 15 days & 11 hours
- Approximately US\$ 1M to repair, with Reroute

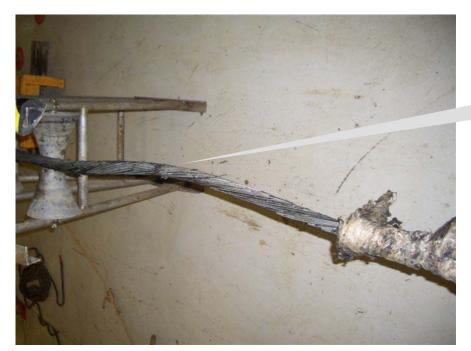
Fault during September-2009

Cable was out of position by approximately 400 meter to the North of the as-laid route. The cable showed signs of external aggression and appeared that the armor wire was embedded into the polyethylene jacket causing the shunt fault.

Exposed armor wire and stress, possible fault location

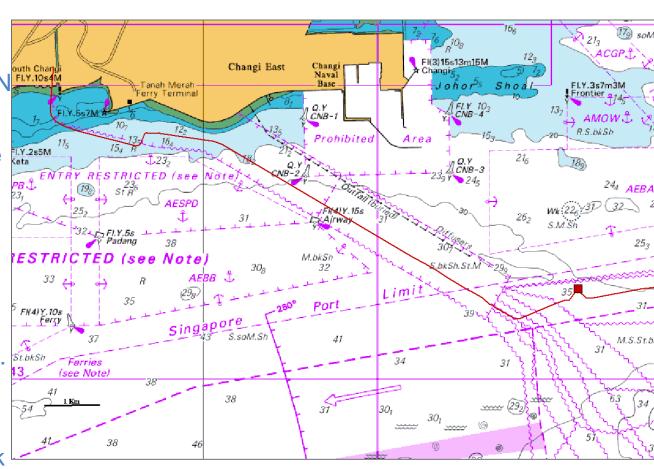
Fault during October 2009

- Shunt Fault
- Fault location, 1° 17.0N and 104° 3.60E
- Within Westbound Lane Of TSS
- Ship departs for Repair Grounds, November 11th, 21:54
- Time to get to Repair Ground, 2 hours 48 min. Total Time of Repair 7 days & 14 hours
- Approximately US\$300k to repair

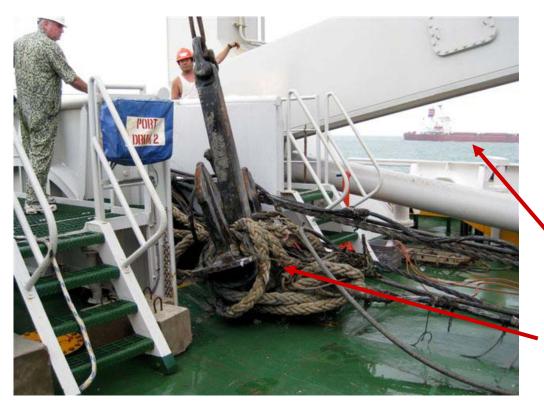
Greatest Threat to Submarine Cables in the Singapore Straits

Vessel illegally anchoring near fault location of June repair

Anchor recovered during June fault with cable wrapped around

- 1. Stricter Enforcement of rules within designated waterways
- 2. Enhanced Charting and education on the consequences of illegal anchoring
- 3. Better Cable Awareness within the Global Commercial Fleets
- 4. Move Anchorage Zone Further from Cable Areas
- 5. Proactive prevention of illegal anchoring by regional governments
